ERBIL MATERNITY AND PEDIATRIC
HOSPITAL
ERBIL, IRAQ

SUSTAINMENT ASSESSMENT

SIGIR PA-06-094
APRIL 19, 2007

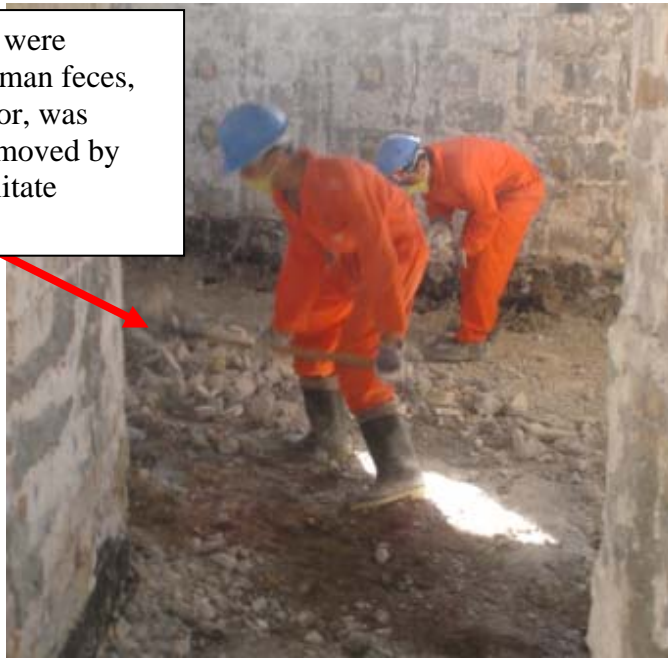
External toilets were plugged and human feces, piled on the floor, was scooped and removed by workers to facilitate renovation.

Site Photo 1. External toilet prior to renovation. (USACE photo taken 18 June 2006)

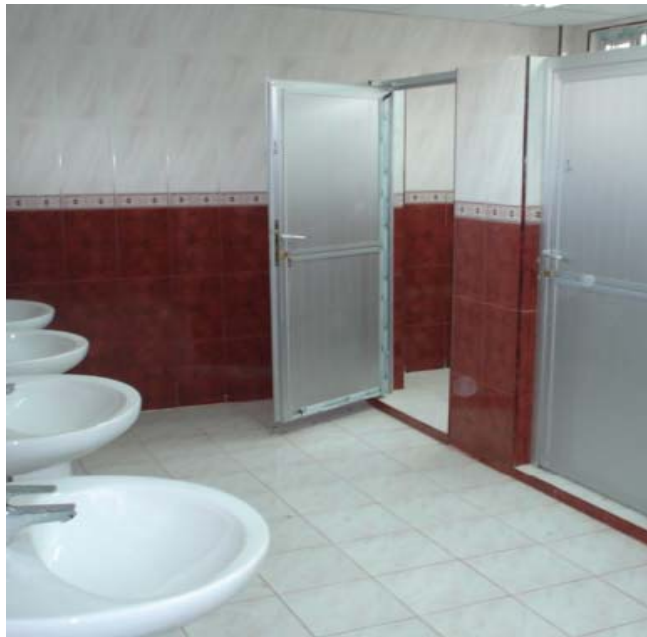
Site Photo 2. External toilet following renovation. (USACE photo taken 18 Jan 2006)

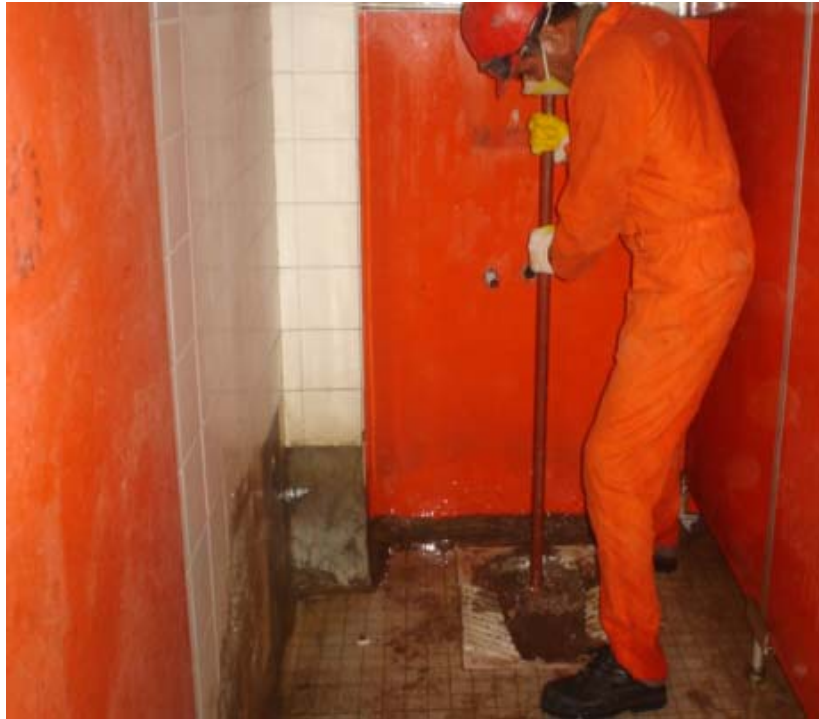
Site Photo 3. Water closet/toilet prior to renovation. (USACE photo taken 11 August 2005)

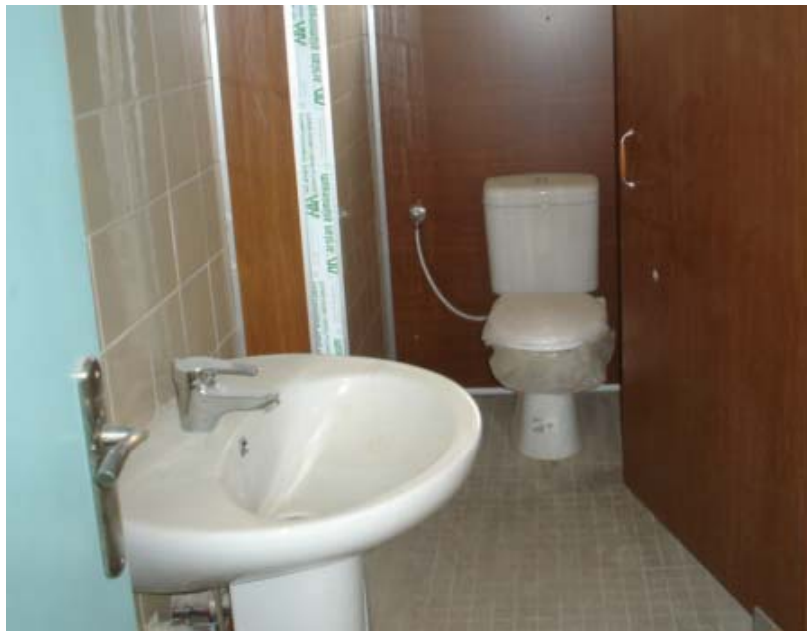
Site Photo 4. Toilet with sink following renovation. (USACE photo taken 8 Jan 2006)

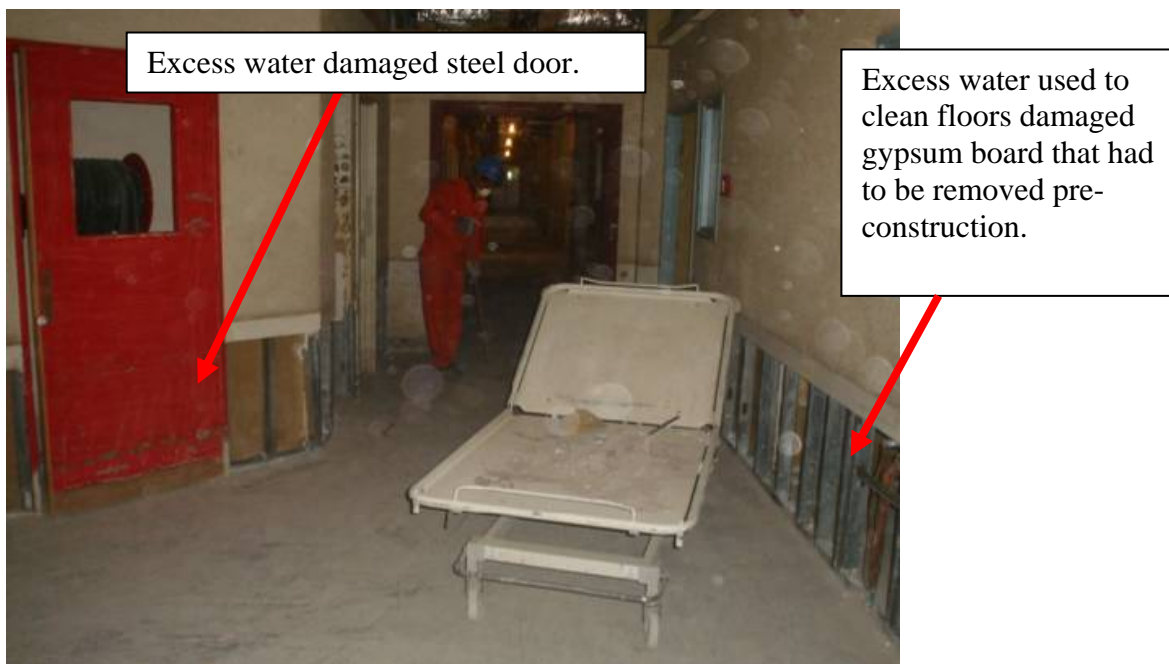
Site Photo 5. Hallway prior to renovation. (USACE photo taken 18 June 2005)

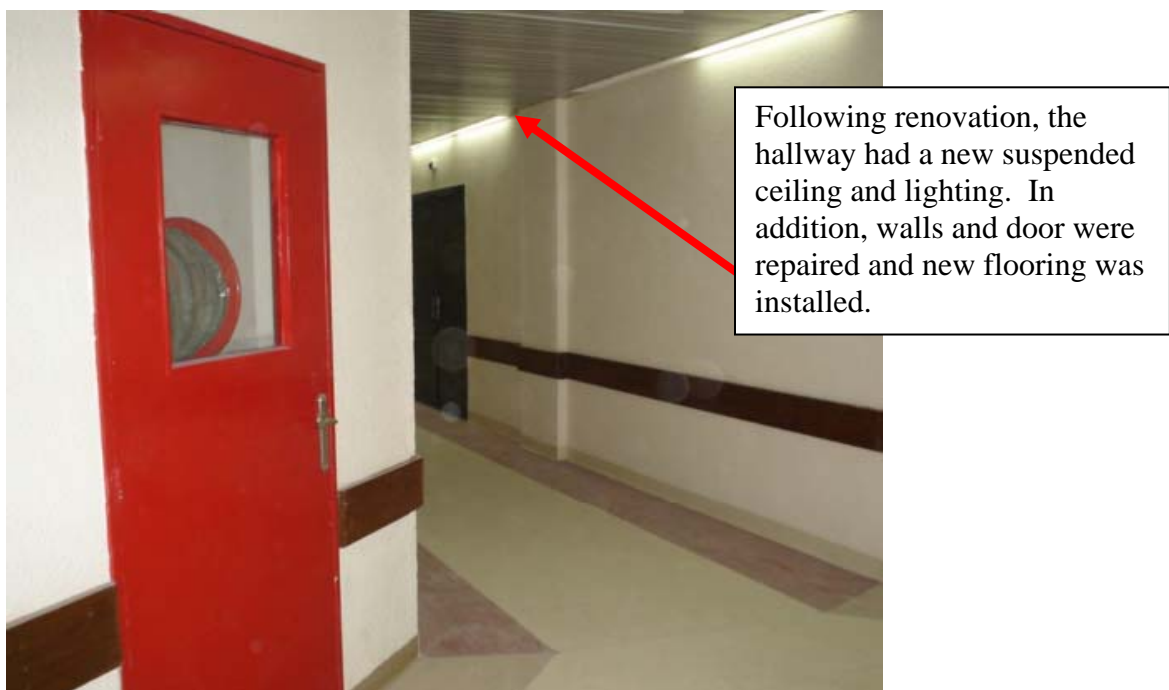
Site Photo 6. Hallway following renovation. (USACE photo taken 8 Jan 2006)

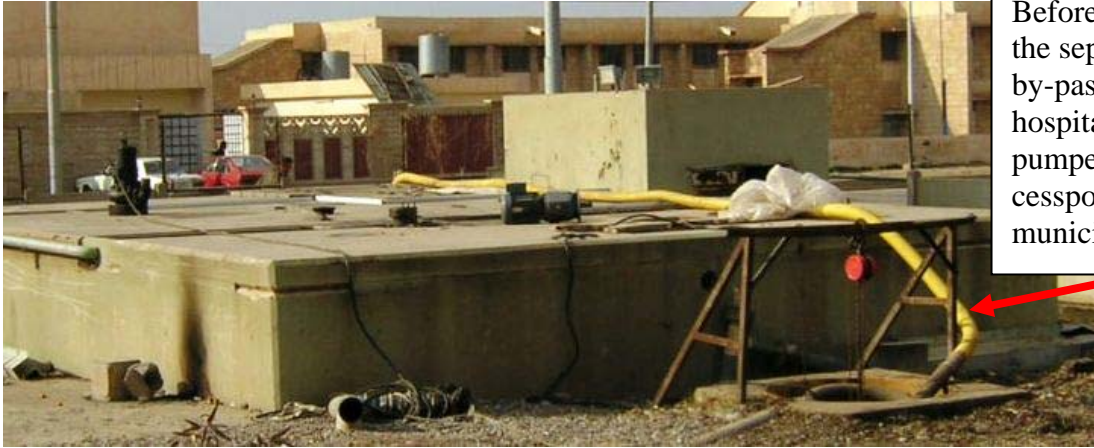
Before renovation, the septic tank was by-passed and hospital sewage was pumped from the cesspool to the municipal system.

Site Photo 7. Plugged septic tank prior to renovation. (USACE photo taken 4 Jan 2005)

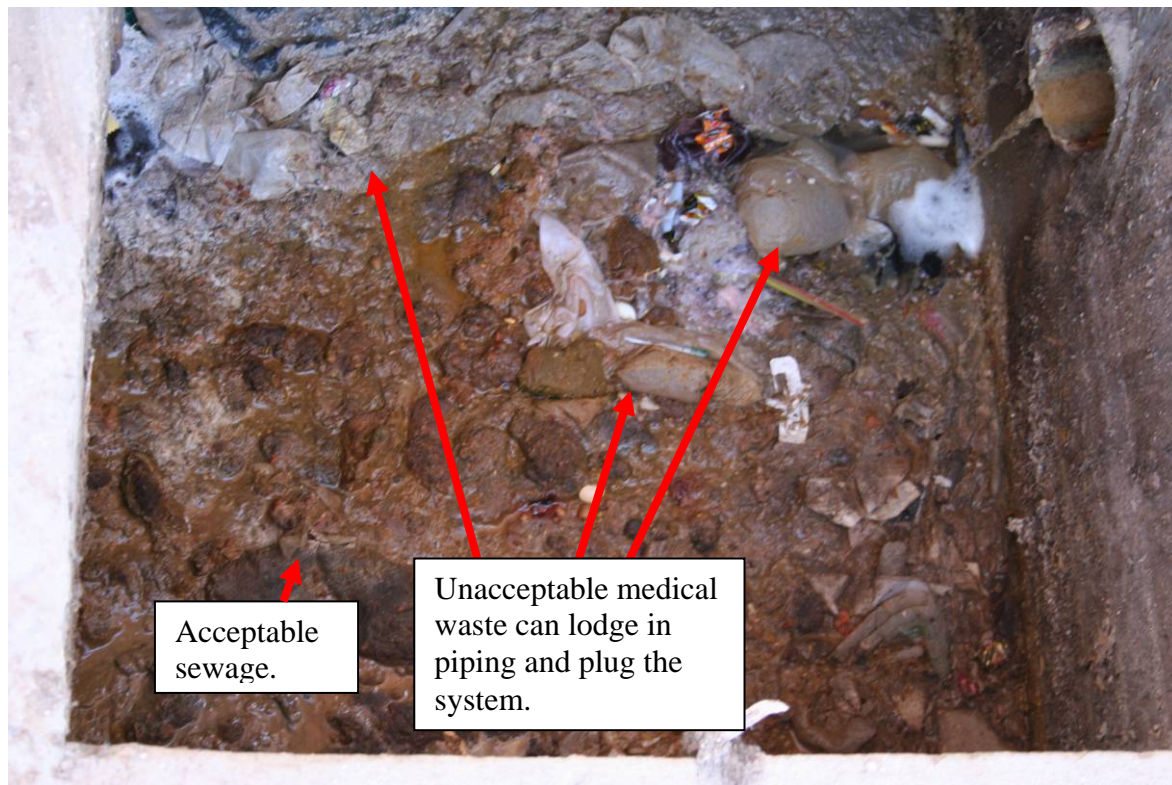
While SIGIR inspectors cannot be certain of the primary cause of such back ups, they did not find this was likely due to inadequate design or insufficient renovation work. Instead, they found a significant contributing factor, if not the primary cause, to be the hospital staffs' improper disposal of medical waste materials into the drains and sewer system. During the site visit, SIGIR inspectors observed large quantities of medical waste materials in the sewer system's traps, manholes, and in septic tank (Site Photo 8).

Site Photo 8. Medical waste material found in manholes and traps

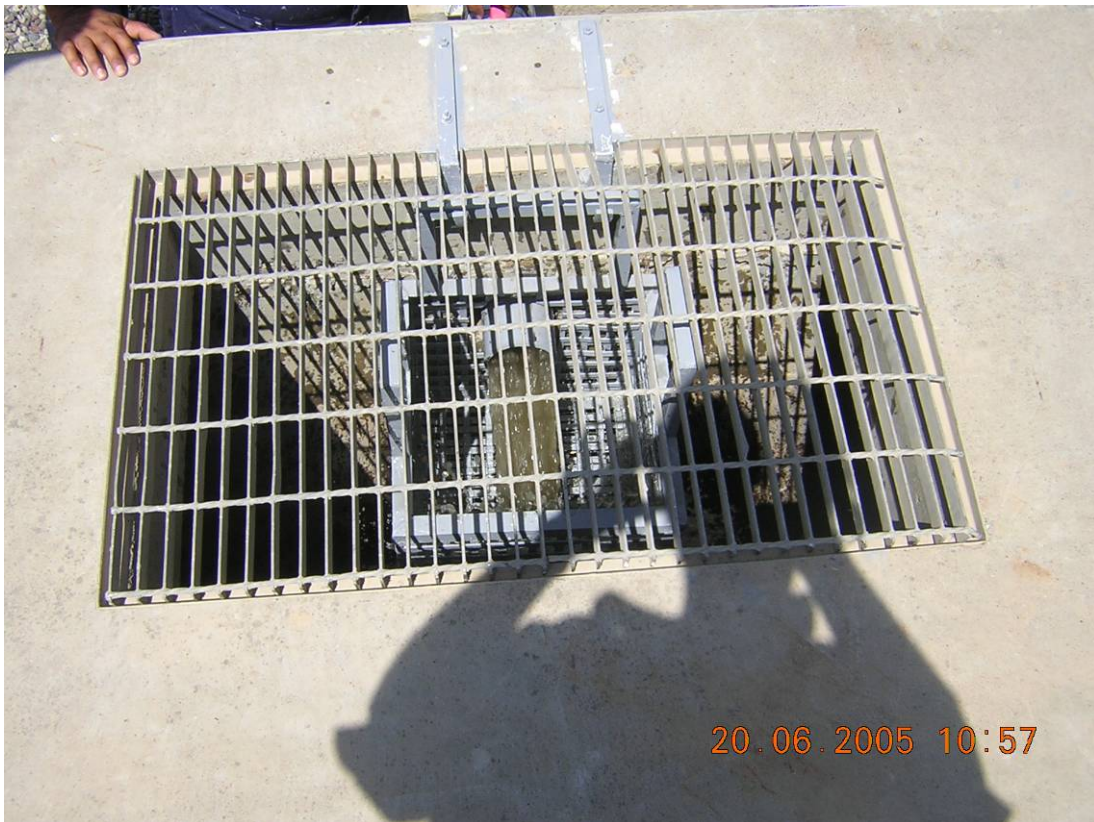
Site Photo 9. Inlet to septic tank was clean during commissioning. (USACE photo)

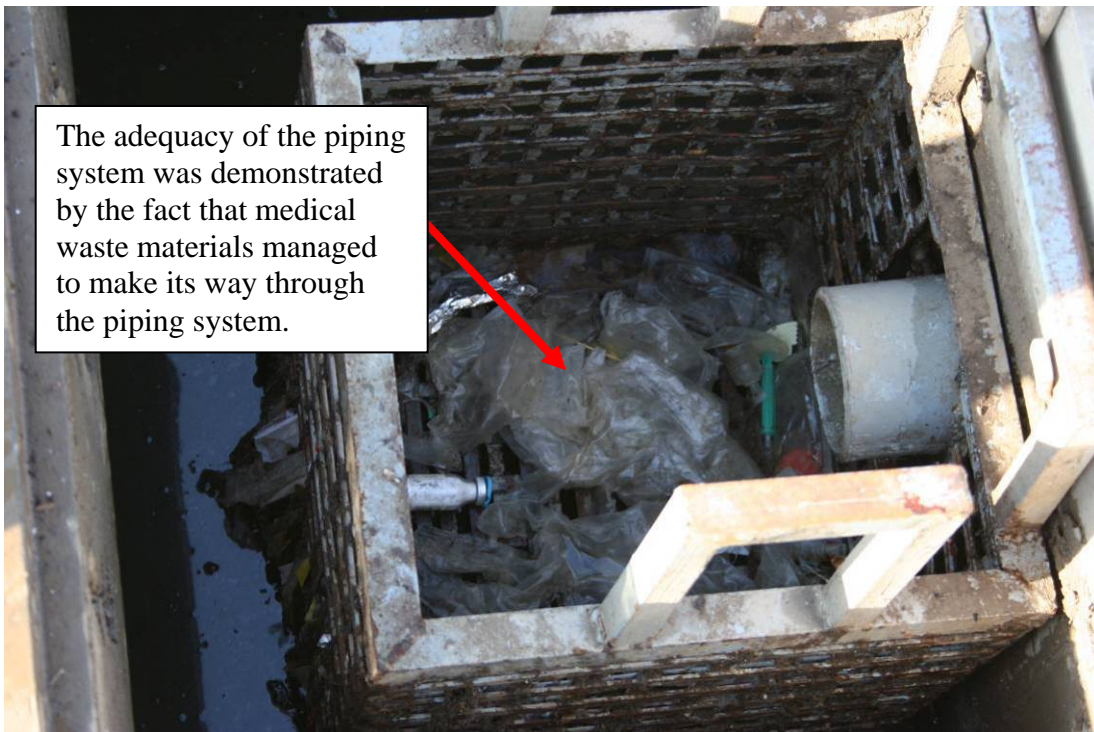
The adequacy of the piping system was demonstrated by the fact that medical waste materials managed to make its way through the piping system.

Site Photo 10. Inlet to septic tank as observed

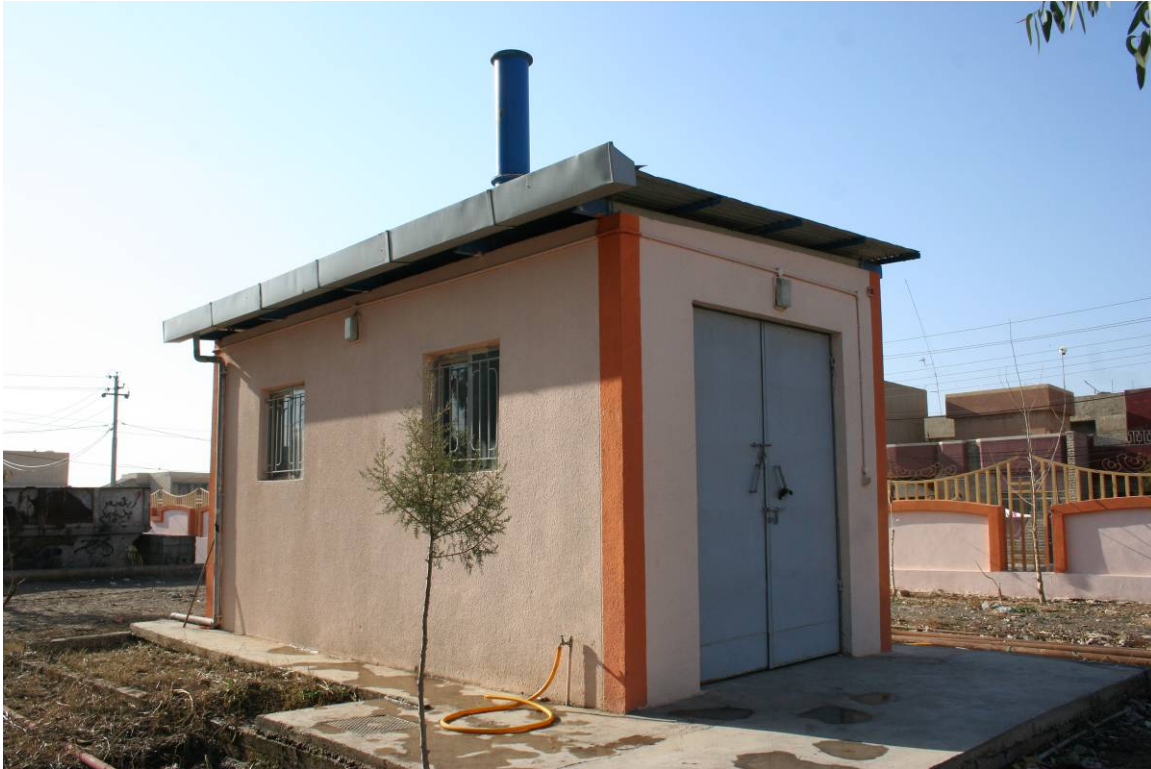
Site Photo 11. Incinerator building

SIGIR inspectors found the incinerator building to be well constructed, but the doors were locked with a conventional padlock. Upon inquiry, the inspectors were told by hospital maintenance and sanitation workers that they did not know where the key was and that the new incinerator was not used to dispose of waste materials since the trained operator(s) were no longer employed at the hospital. The inspectors chose not to question hospital managers about the departure of the trained operators.

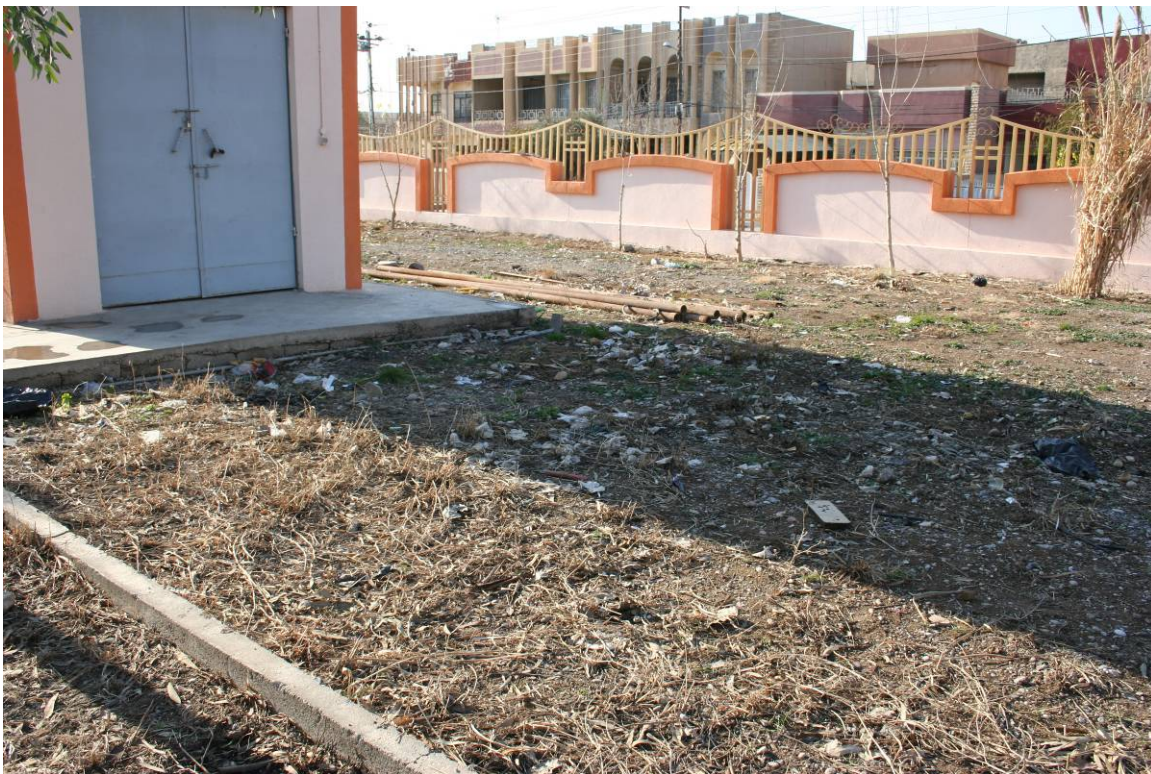
SIGIR found medical waste at various locations at the facility. As previously mentioned, they were found in the sewer system. They were also found on the ground near the door of the incinerator building (Site Photo 12). They were also scattered about the area between the sewer system's cesspool and the rear of the incinerator building (Site Photos 13, 14, and 15).

Site Photo 12. Medical waste materials scattered on the ground area in front of the new incinerator.

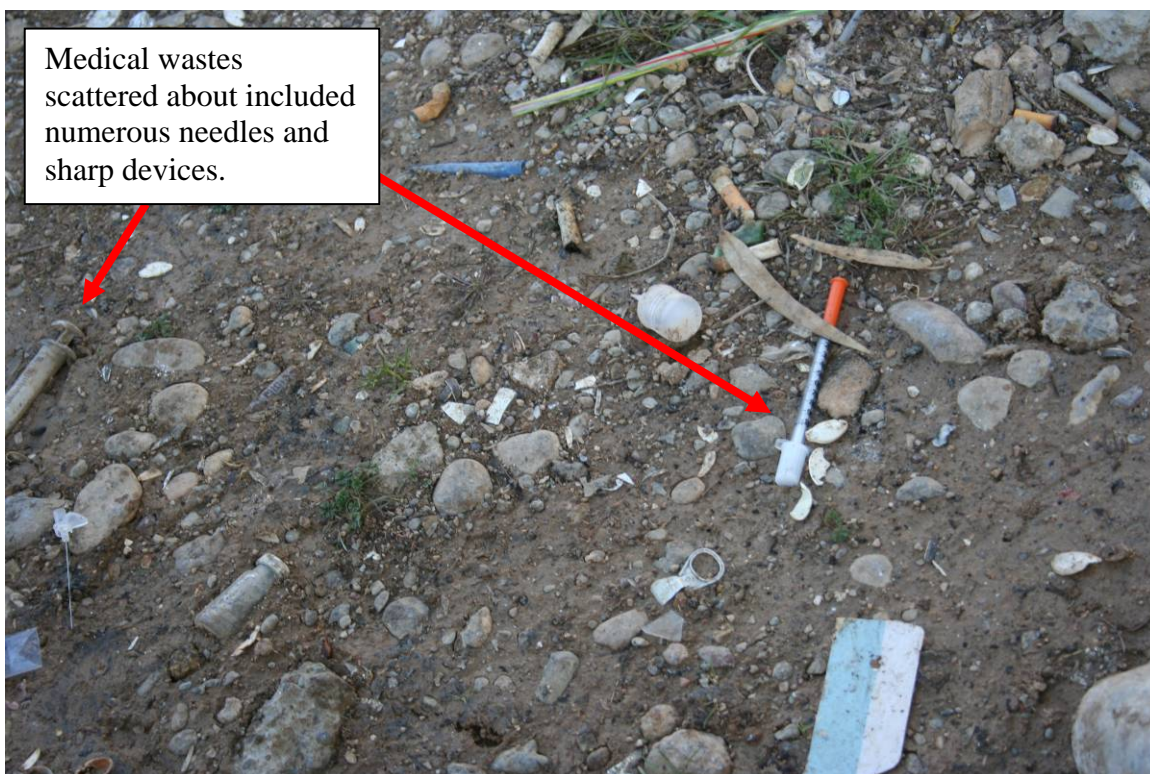
Site Photo 13. Hypodermic needles and other medical waste.

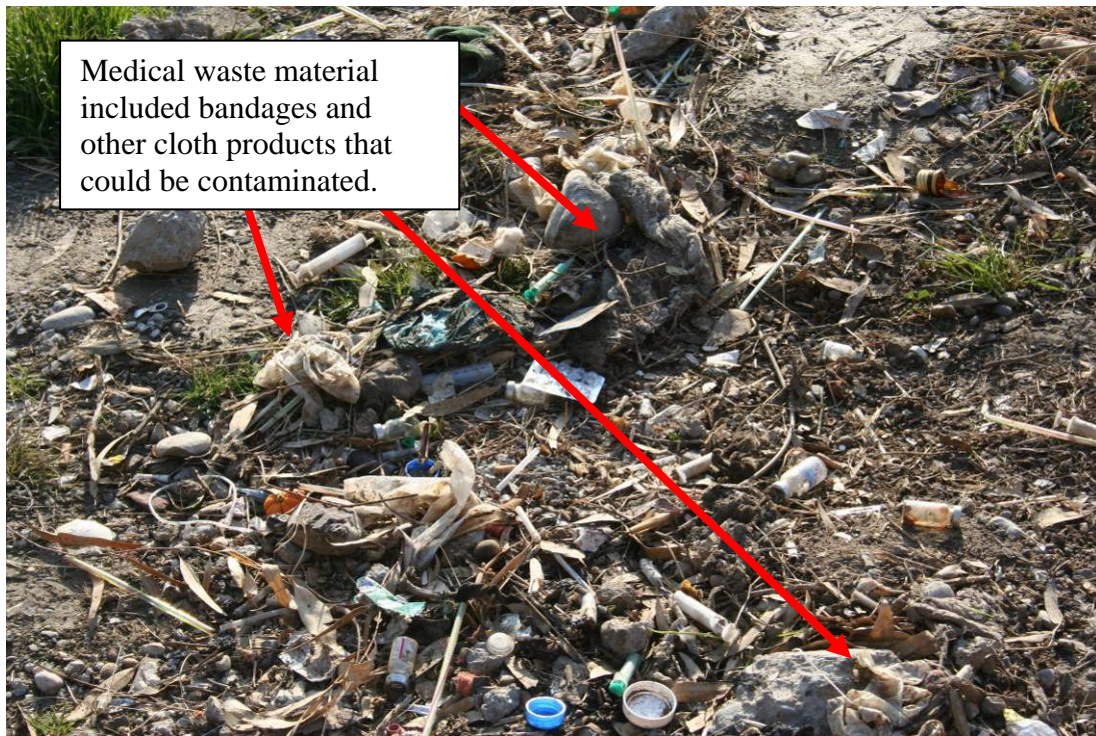
Site Photo 14. Bandages and other medical waste on the ground.

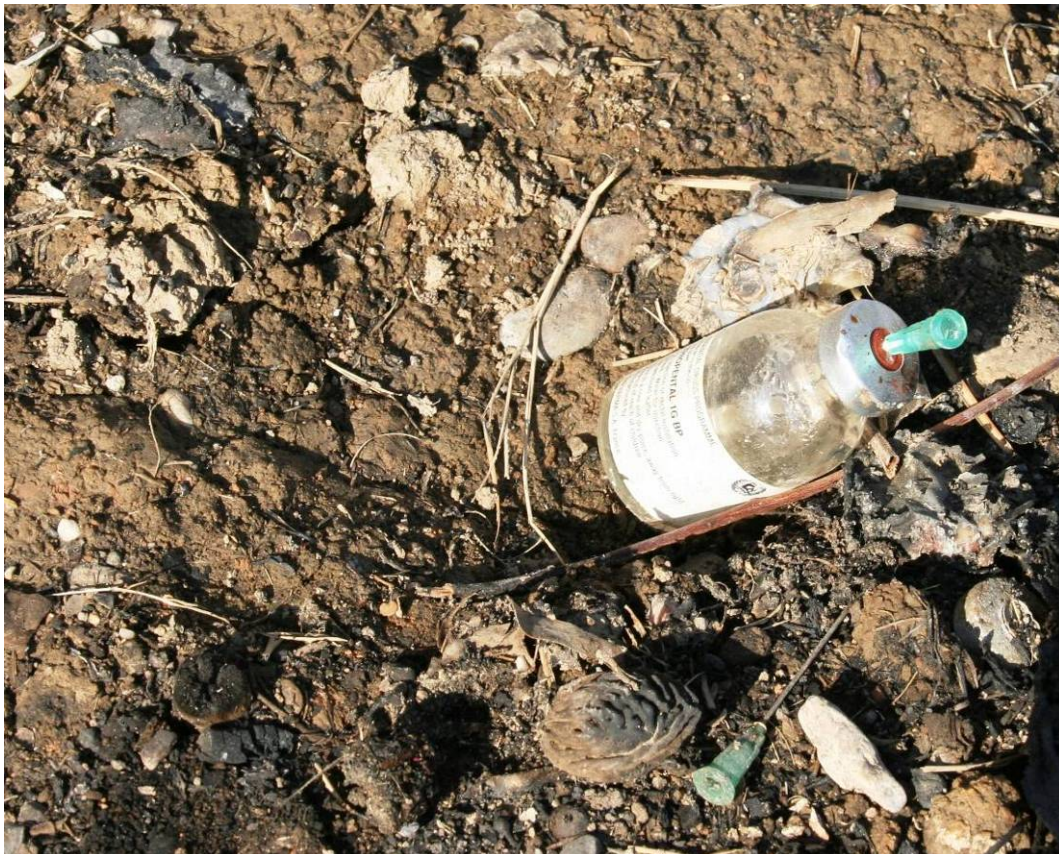
Site Photo 15. Needles and other medical waste.

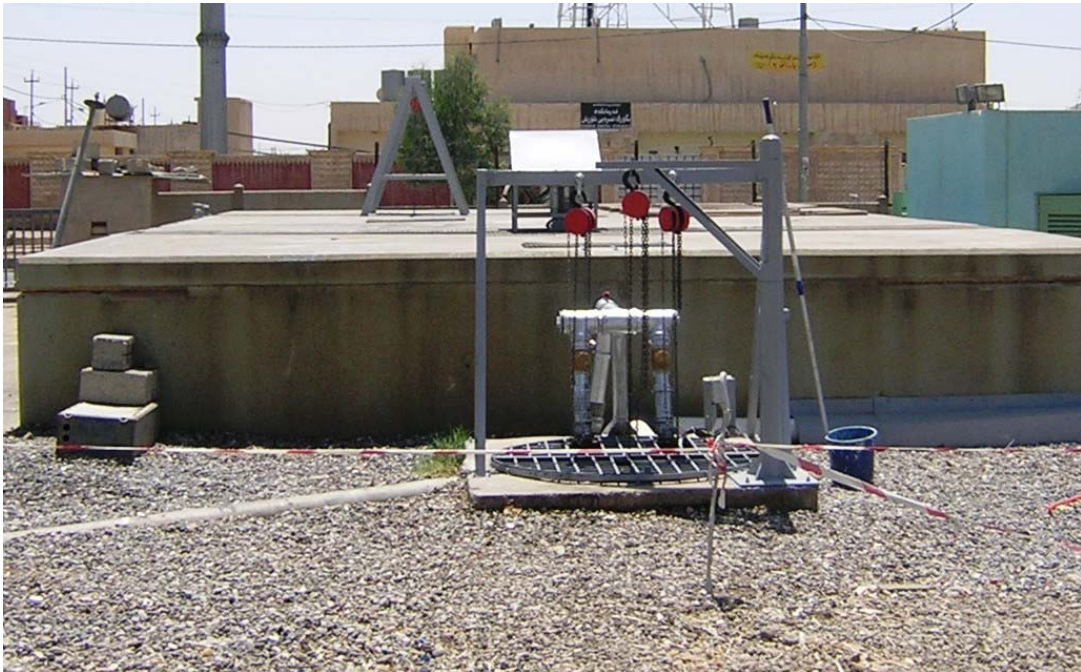
Site Photo 16. Immediately following renovation, area behind the incinerator was clean. (USACE photo)

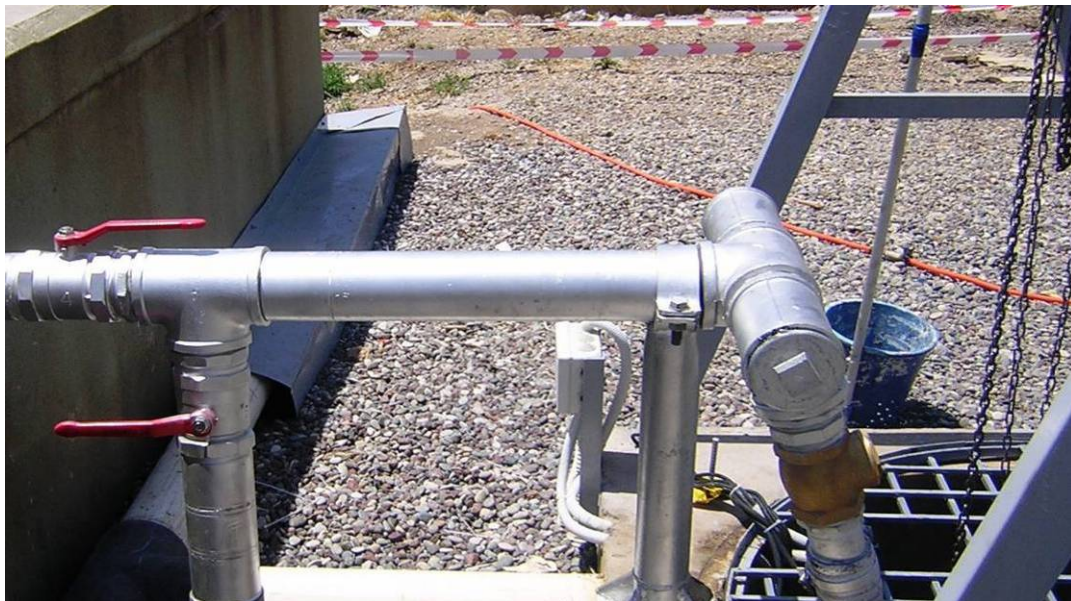
Site Photo 17. Immediately following renovation, the area adjacent to the cesspool was clean. (USACE photo)

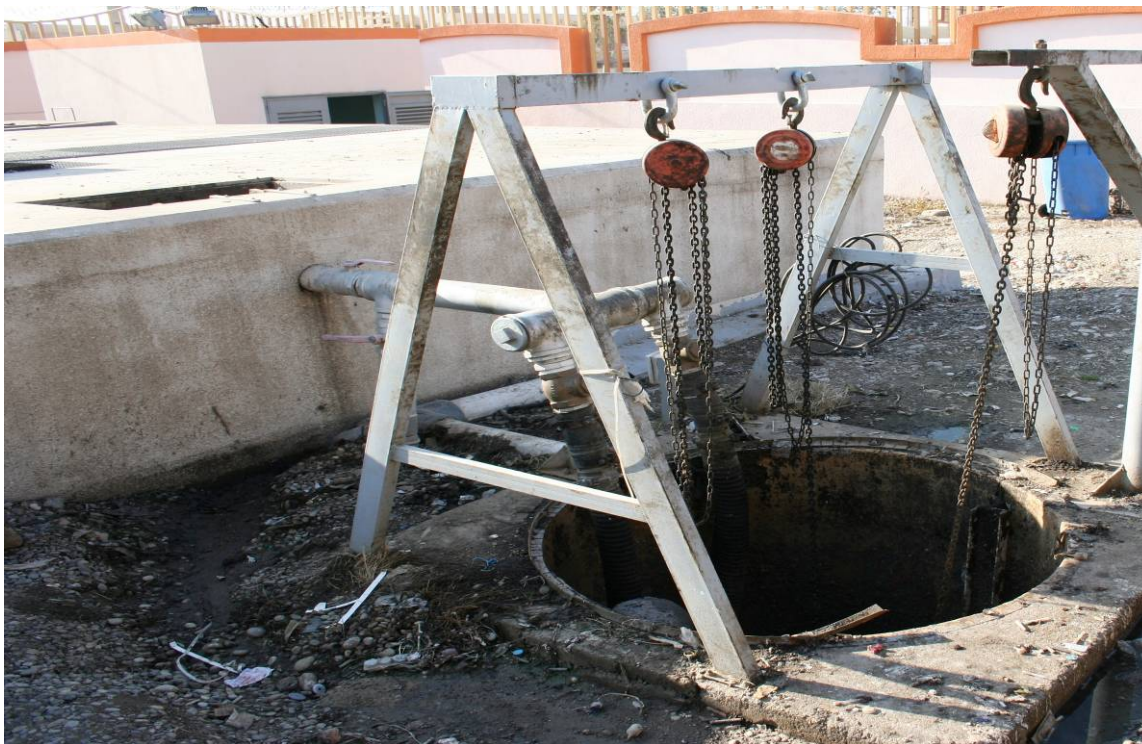
Site Photo 18. During the inspection, the area between the cesspool and septic tank was littered with ineffectively burned medical waste materials.

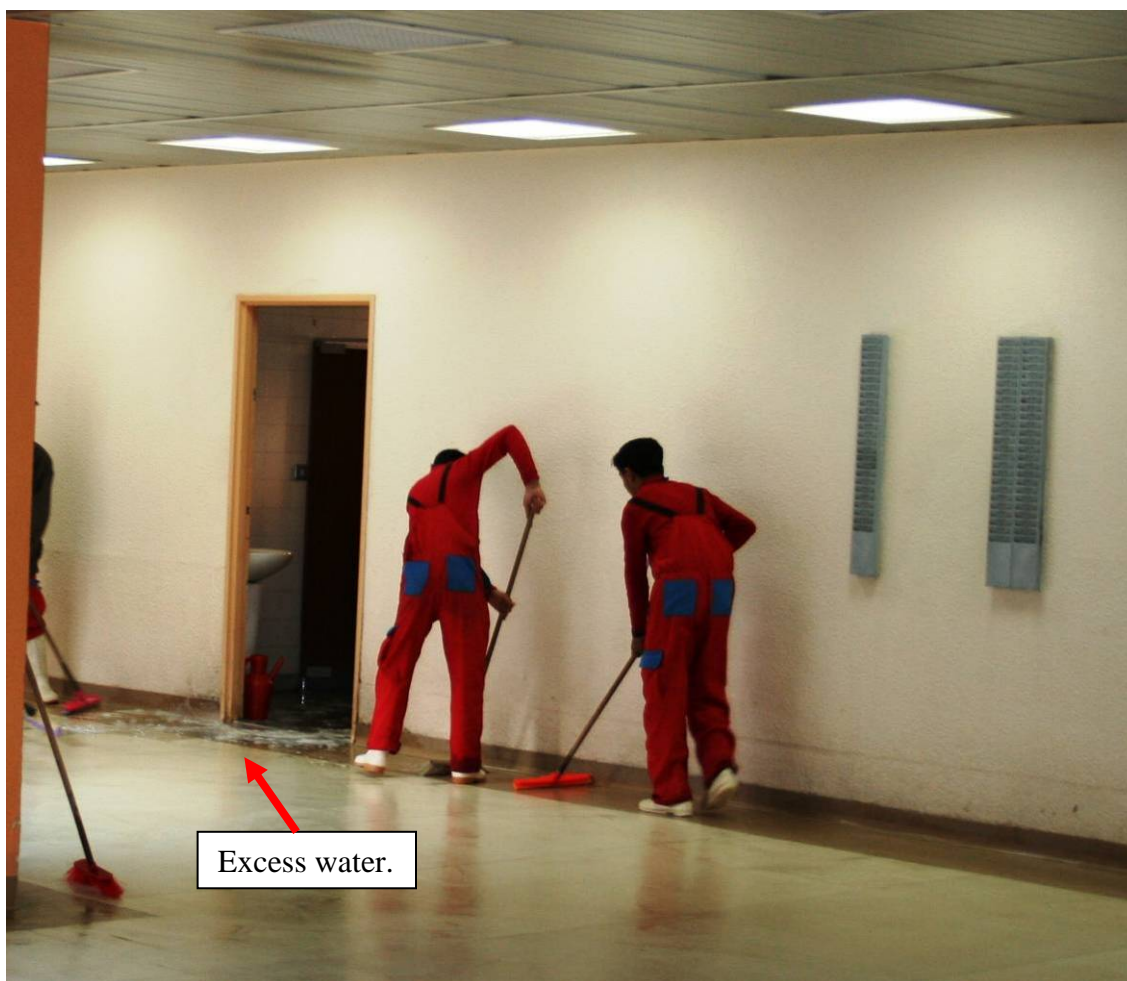
SIGIR inspectors observed cleaning practices that very likely caused and will continue to cause damage to the walls, floors and the basic structure of the facility. Cleaning crews were observed cleaning the lower and upper story hallways with too much water (Site Photo 19).

Site Photo 19. Cleaning crew workers used too much water to clean floors.

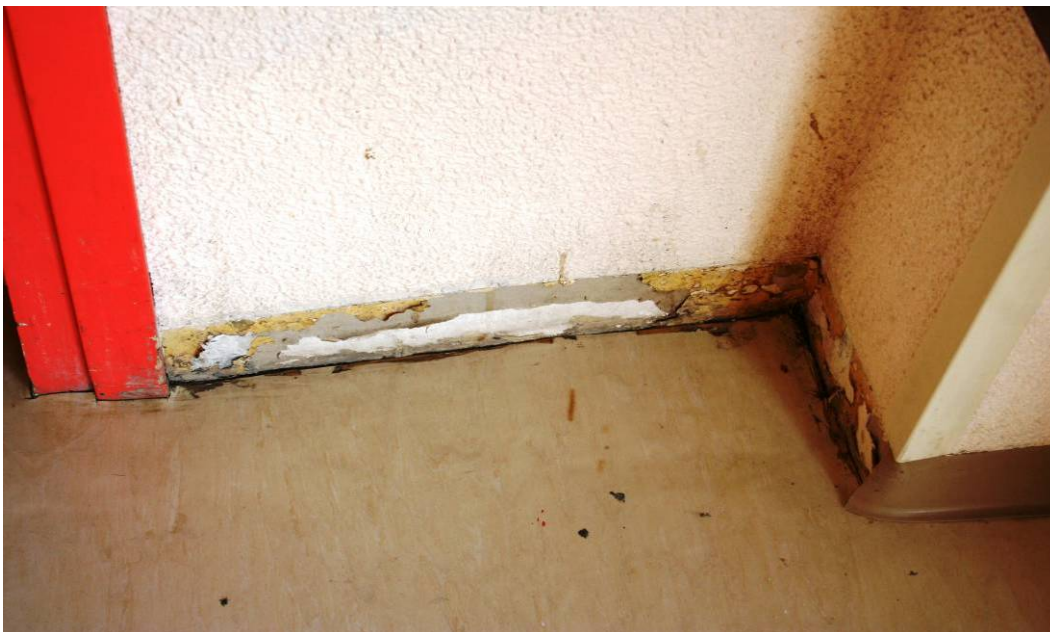
According to the USACE RE, this practice has caused water to leak or migrate from the hallways and bathrooms to other places in the facility. It is reasonable to conclude that contaminated water from an upper story hallway or bathroom could migrate to a first floor wall or leak directly through the ceiling. In addition to leading to damage of the walls and floors, the water could spread contaminants. Site Photos 20 and 21 show the damage caused by water migrating from the upper story to the walls of the lower story. In both photos, potentially harmful mold³ or mildew was visible on the moist drywall. Site Photo 22 shows the room of an expectant mother who had been moved because too much water had migrated from the upper story to her room on the lower story.

Site Photo 20. Water saturated and damaged wall.

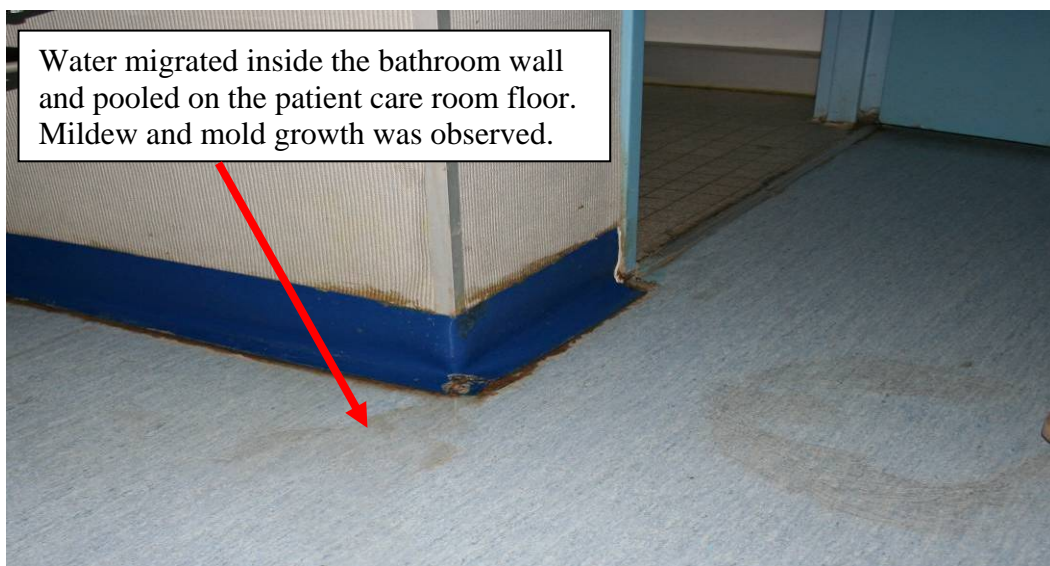
Water migrated inside the bathroom wall and pooled on the patient care room floor. Mildew and mold growth was observed.

Site Photo 21. Water saturated wall and mildew and mold growth.

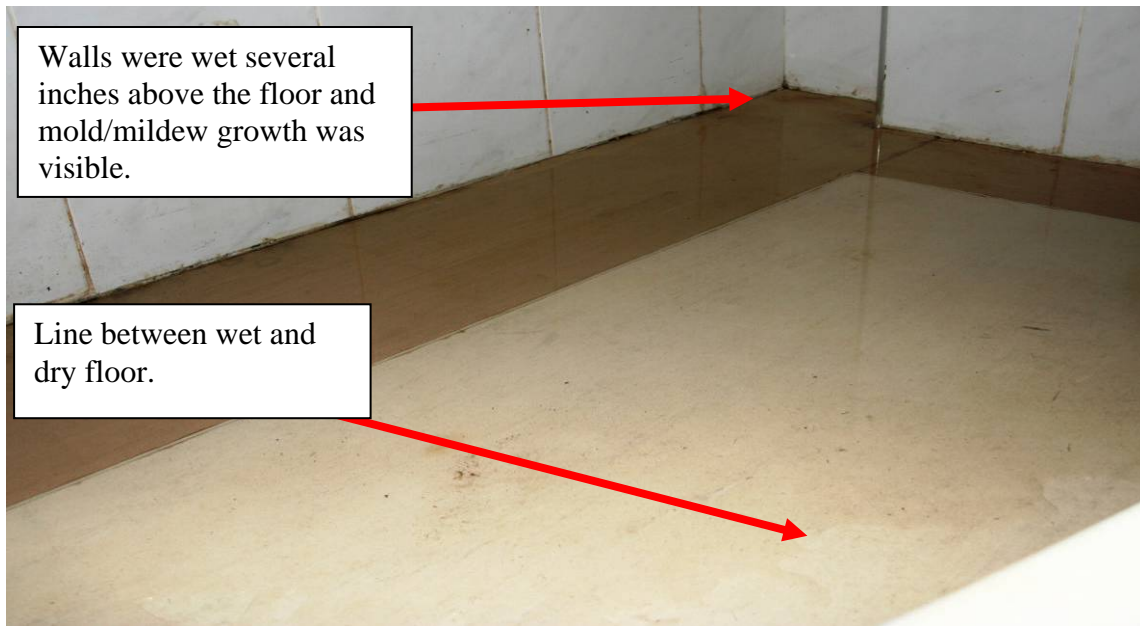
Site Photo 22. Unusable room after water migrated through the walls.

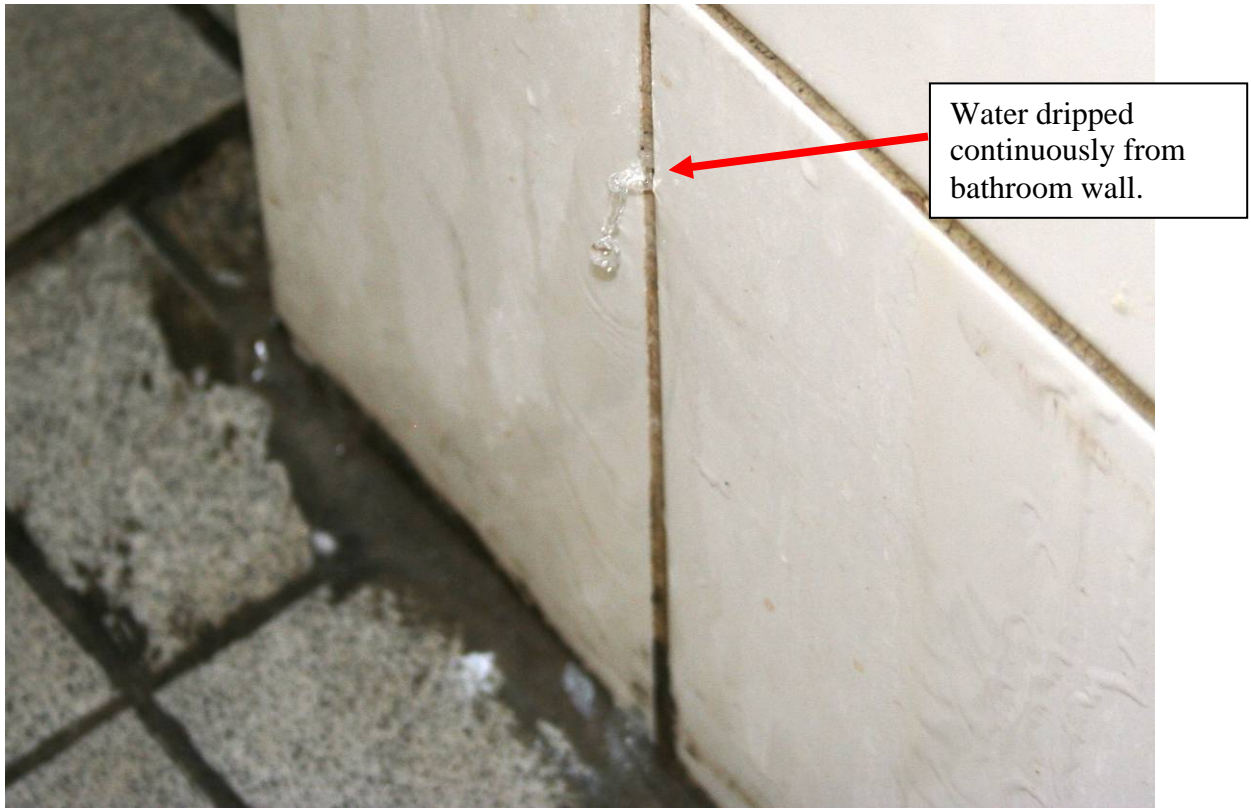
Inspectors also observed an upper floor bathroom where water dripped continuously from the wall (Site Photo 23). The water pooled on the bathroom floor and leaked through the ceiling to a lower story storage room. The damage caused to the ceiling of the storage room is shown in Site Photo 24. While the inspectors could not observe the source of the water, they suspected it was caused by a broken or loose pipe, coupling, or fitting inside the wall, not by workers using too much water to clean floors. The RE advised that the bathroom in question was not included in any renovation work performed by the contractor.

Site Photo 23. Steady dripping of water from a bathroom wall.

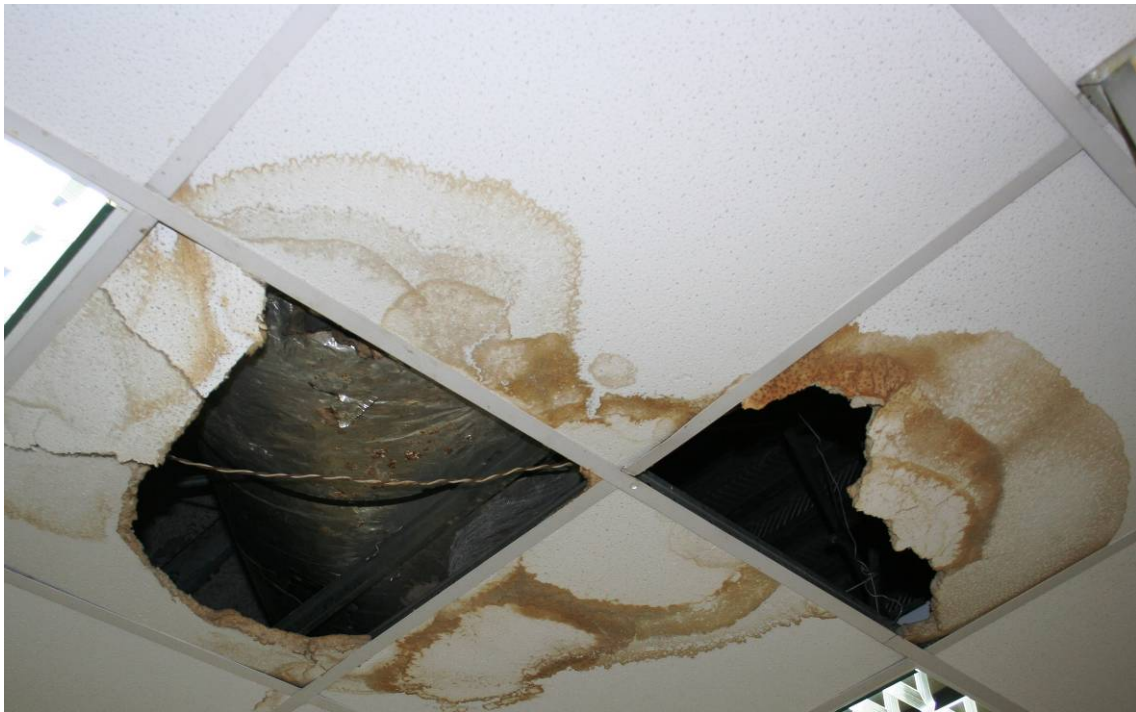
Site Photo 24. Damage from dripping water shown in Site Photo 23.

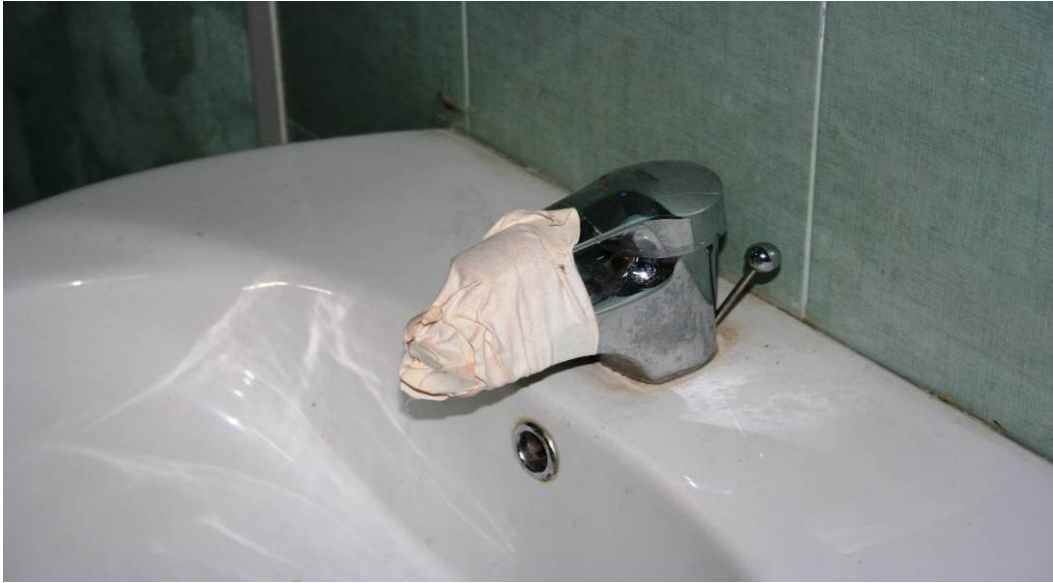
SIGIR inspectors also observed that numerous sinks in patient care rooms were either broken, missing faucet handles or drain pipes, or purposely rendered non-operational. Site Photo 25 shows a sink in a patient care room where the faucet was rendered non-operational, while Site Photo 26 shows a sink, in another patient care room, which was missing the drain pipe/trap assembly. Hospital officials told SIGIR inspectors that parts (drain piping/trap assemblies) were taken to repair sinks elsewhere in the hospital.

Site Photo 25. Some patient care room sinks were unusable.

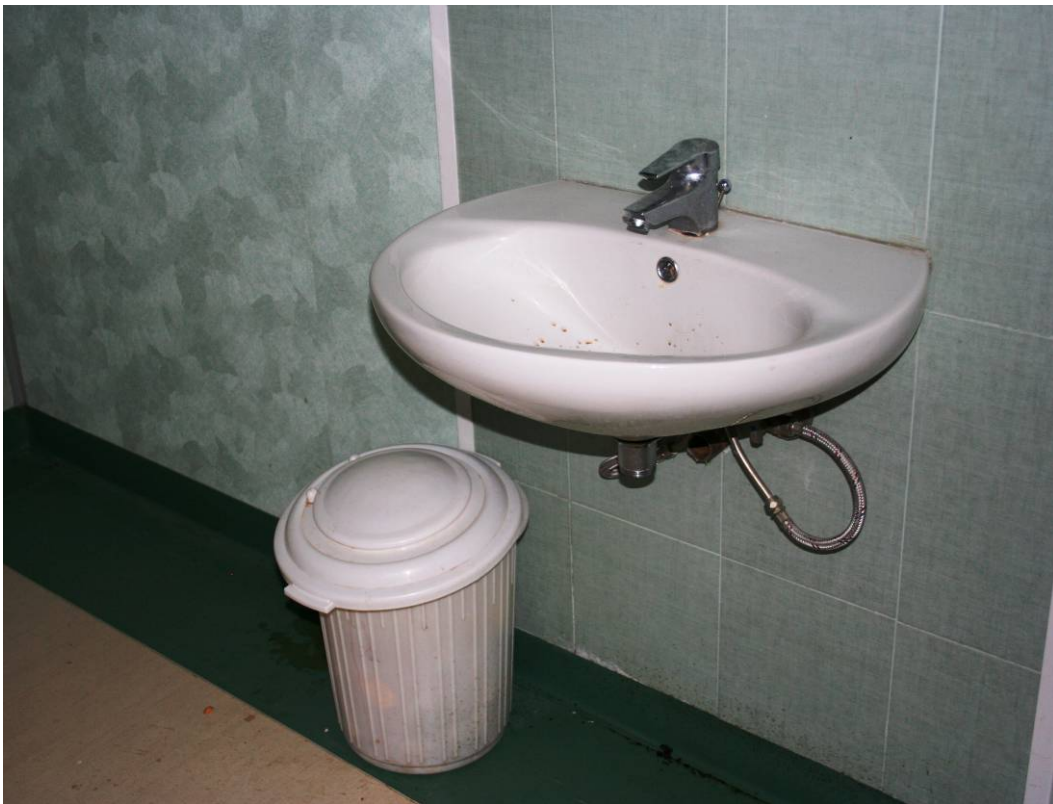
Site Photo 26. Drain pipe/trap was removed from patient care room sink.

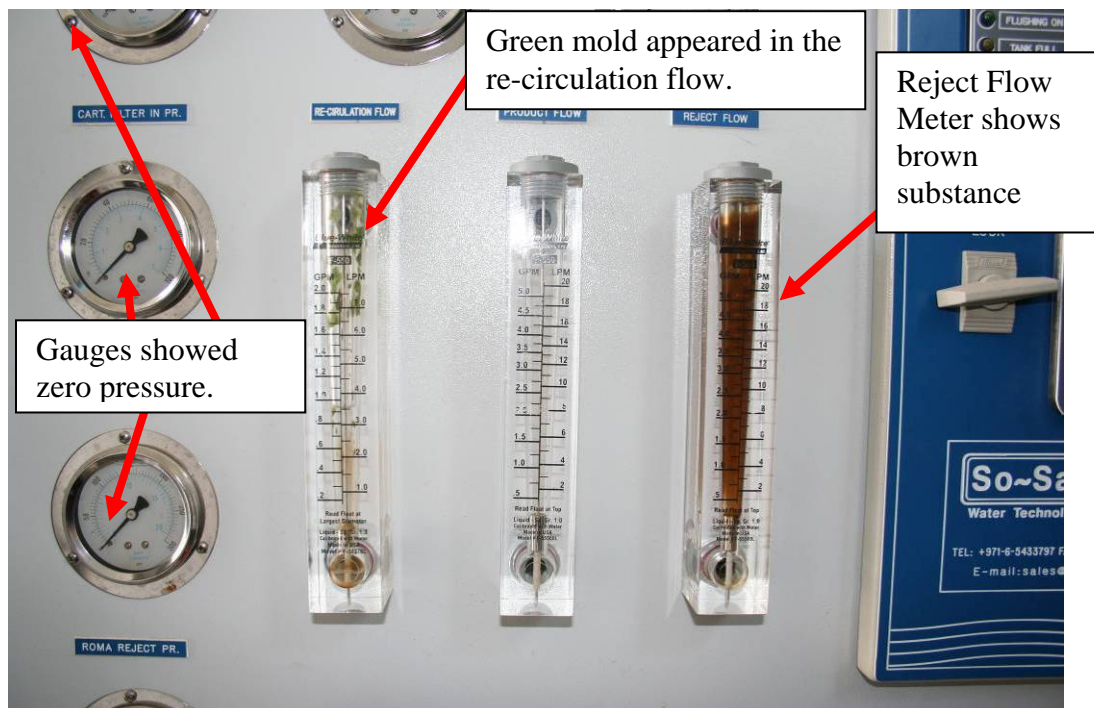
Although turnover documentation indicated that the USACE turned over a fully functional RO system on 1 May 2006, the system was not operational when the SIGIR inspectors conducted their site visit on 19 January 2007. Site Photo 27 shows the front panel of the RO unit with flow meters and pressure gauges. A mold like buildup was observed in the left re-circulation flow meter, while a dark substance stained the reject flow meter and the pressure gauges registered zero pressure.

While SIGIR could not verify when the RO system ceased to function, it appeared that biological contamination fouled RO membranes. It is likely that the RO system's membranes have been permanently damaged based on warnings disclosed in the manufacture's operations and maintenance manual.

The inspectors found that the manufacture's RO preventative maintenance program, if properly followed, would likely have prevented the biological fouling. However, visual evidence indicated that the preventative maintenance program was likely not followed and the RE agreed with this assessment. The inspectors observed new filters piled in the corner of the RO room that could have been used for preventative maintenance.

Site Photo 27. RO Unit's instrument panel.
